FINAL REPORT  
IHR-513  
CRACK CONTROL  
OF  
POZZOLANIC BASES

David L. Lippert, P.E.  
Technical Services Engineer  
and  
Amy M. Schutzbach, P.E.  
Design Technology Engineer

Illinois Department of Transportation  
Bureau of Materials and Physical Research  
Springfield, Illinois

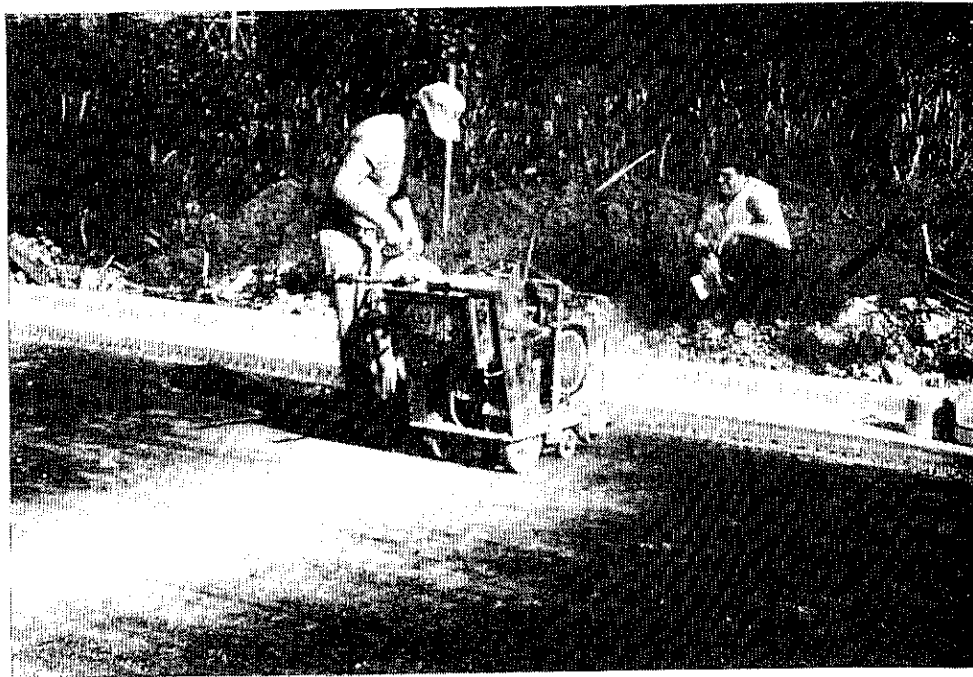
Figure 6 shows a small concrete saw being used to cut 3 1/2-inch deep joints in the LFAM base on the day following placement. The prime coat used to seal the LFAM did not seem to affect the cutting operation.

Figure 6: Sawing joint in primed LFAM base course.

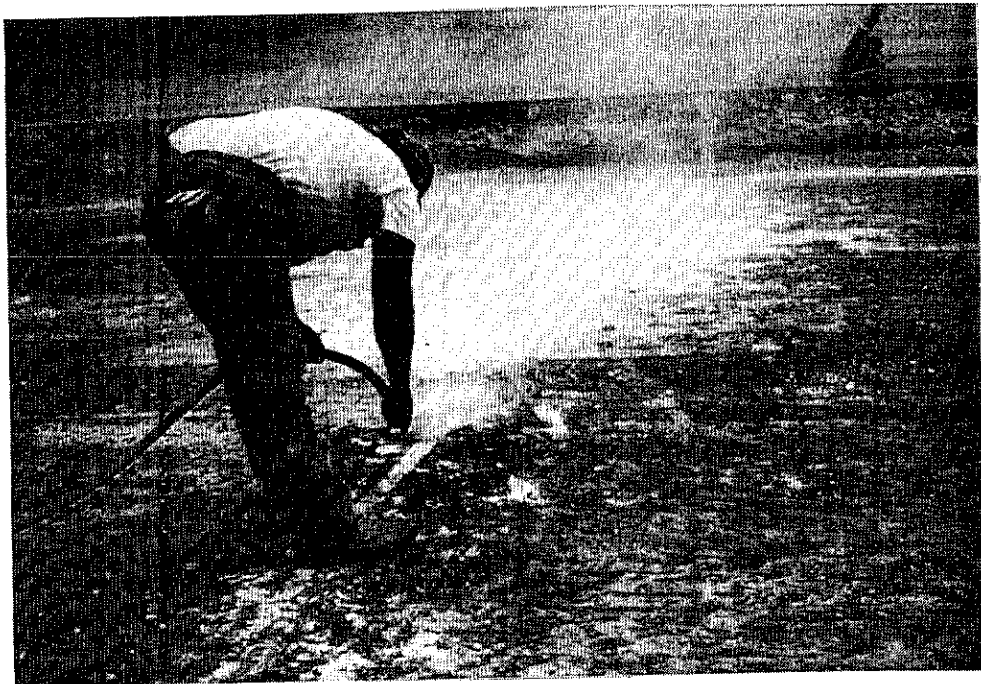
Figure 7 shows the freshly cut joints being cleaned with an air compressor. It was observed that if more than an hour elapsed between the cutting and cleaning operation, the LFAM cuttings had "set up" and it was difficult to clean the joints.

Figure 7: Cleaning joint in LFAM base course.

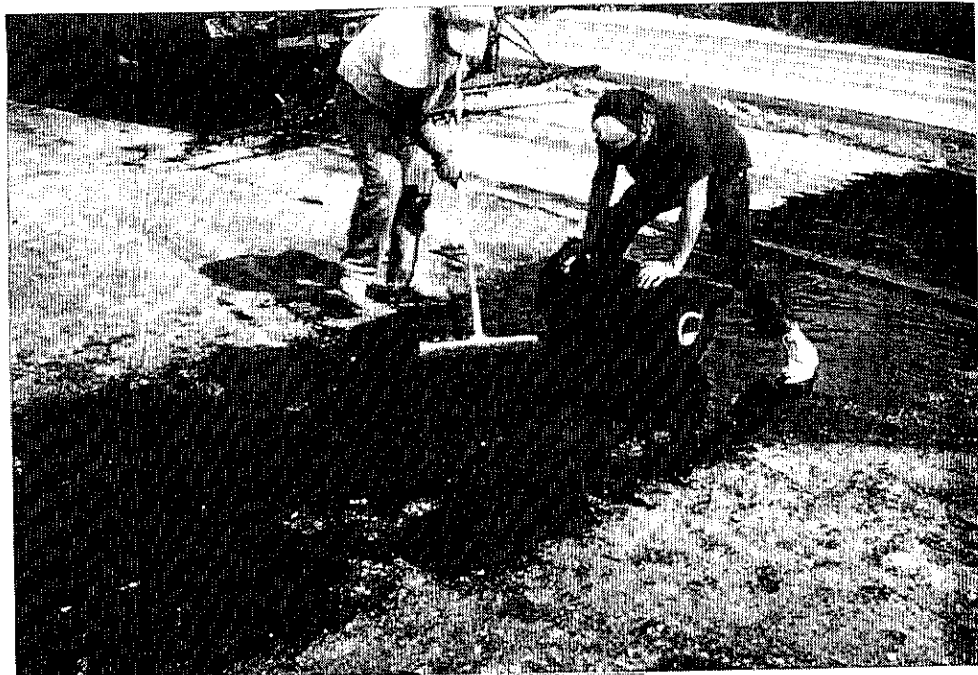
The contractor selected Amopave CEF 4599 as the geotextile to be used for crack control in Design C. After cutting and cleaning the joint, a distributor applied AC-10 to the sealed LFAM base for a distance of 2 1/2 feet either side of the joints, as shown in Figure 8. The 24-inch wide Amopave fabric was centered over the joints and broomed smooth in accordance with the manufacturer's

Figure 8: Placing geotextile fabric over joints in LFAM base course.

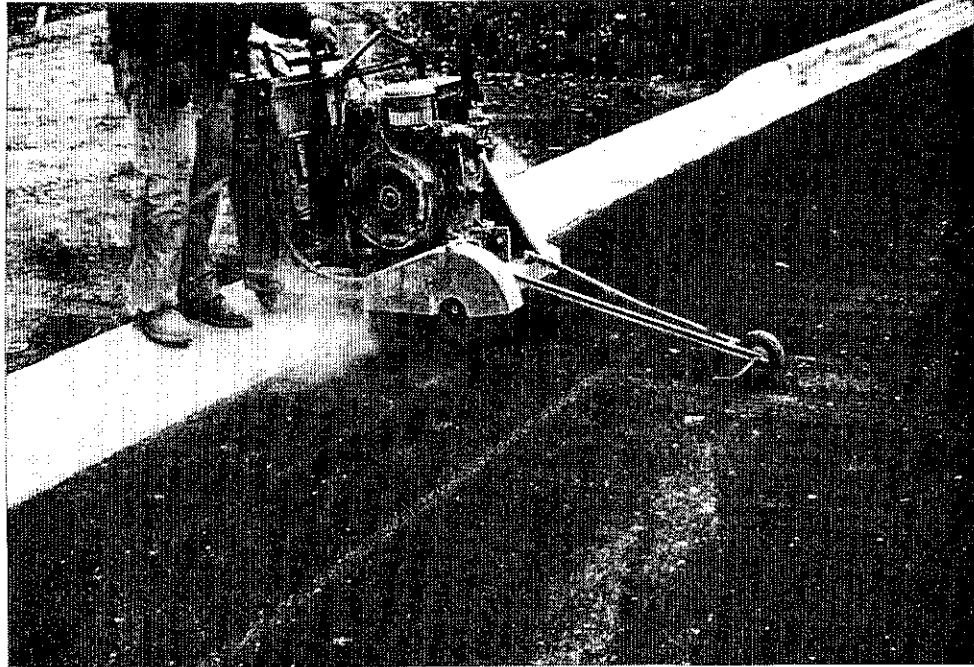
After the surface had been placed on all five lanes, a joint was cut through the surface for the 13 joints of Design B, as shown in Figure 9. The depth of cut varied from 3 to 3 1/2 inches. The joint width was kept constant at 3/8 inch. By string lining from curb joint to curb joint, the surface cuts were aligned directly over the base joints. The joints in the surface were then sealed with a rubber asphalt joint sealer that met the ASTM D 3405 specification.

Figure 9: Sawing joint in the asphalt surface for Design B.
